Inspection Report

Mine Name: Blue Castle
Operator Name: Goldterra

Permit number: S0150077
Inspection Date: March 30,
2007
Time: 12:50-1:00 PM

S0150077, Blue Castle Mine, Goldterra

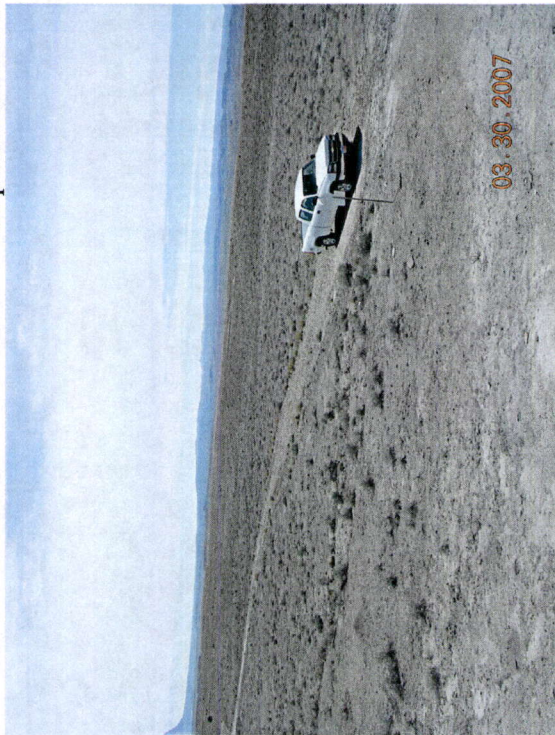
The site includes a pit which I once estimated to be 25 feet deep. I don't believe the pit is quite that deep. There is a graveled road about 1200 feet long leading to the site (Photo 1). Around the pit are piles of excavated material.

Photo 1. The road leading to the site. This road is graveled.

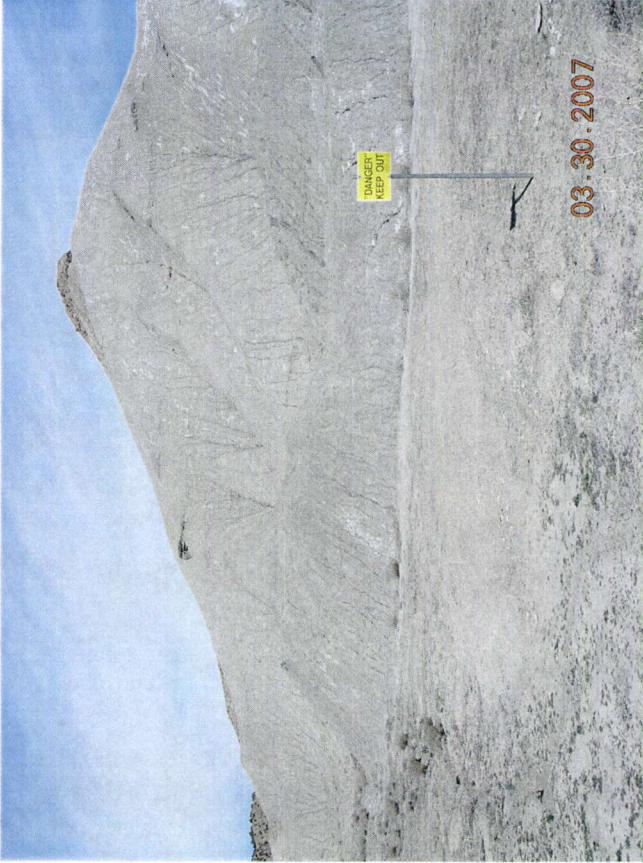
Photo 3. Although difficult to distinguish from surrounding hills, this shows some of the material excavated from the pit.

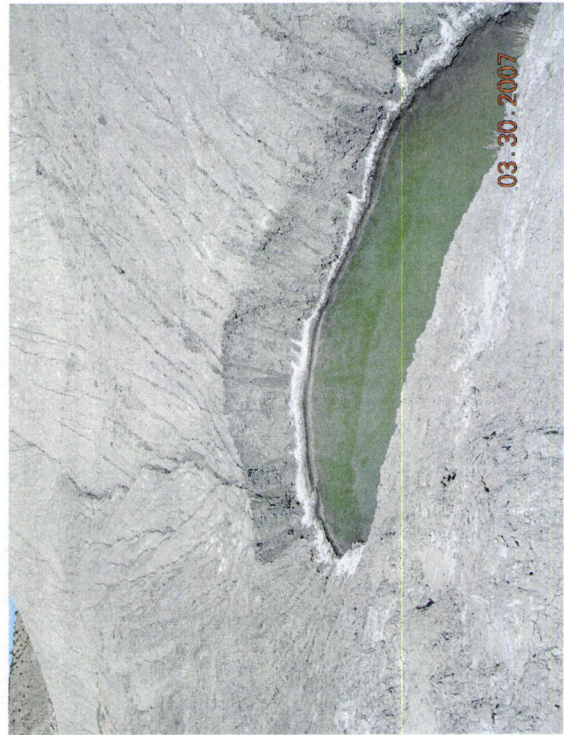
Photo 2. Water in the bottom of the pit.

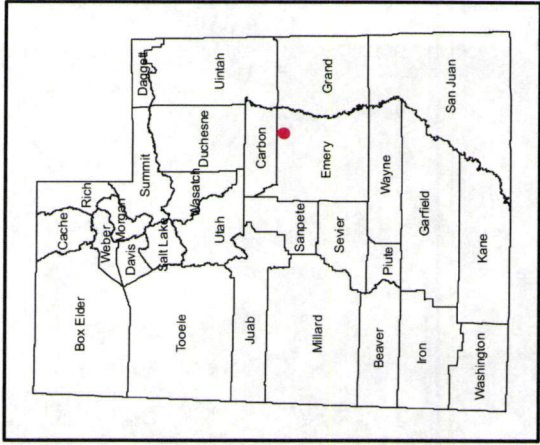
I used a GPS unit to map the disturbed area, and a copy of this map is attached to this report. The total disturbed area, including the road, is 0.87 acres.

Acres Disturbed	0.55
Acres Regraded	0
Acres Seeded	0
Road Acres Disturbed	0.32
Total Acres Disturbed	0.87
Acres Released	0
Acres Excluded	0
Acres PreExisting	0
Acres Prelaw	0
